Cultural Heritage Report Zambia

THE BATOKA DAM ARCHAEOLOGICAL AND INTANGIBLE HERITAGE REPORT-FEBRUARY 2015

Compiled By Richard Mbewe : NHCC, Livingstone - Zambia.

**ARCHAEOLOGICAL/CULTURAL HERITAGE IMPACT
ASSESSMENT ADDENDUM FOR THE PROPOSED QUARRY
SITE ASSOCIATED WITH THE BATOKA GORGE HYDRO
ELECTRICITY SCHEME – ZAMBIA**

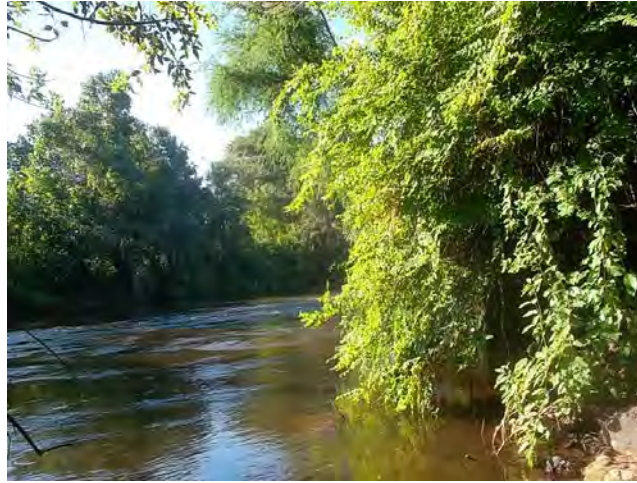
This shrine is located within the Victoria Falls eastern cataract area. The site is still in use though infrequently. This site is used for disease-cleansing rituals. Here the Bedyango (Female Co-Ruler) exercises her office's miraculous gift of healing various diseases. This site was partly disturbed by the construction of sluice intake canals for power generation

by ZESCO Ltd. Despite this disturbance, the site is still revered by many elders of the chiefdom.

Figure 2: Nsamba Dwazi shrine in the Victoria Falls

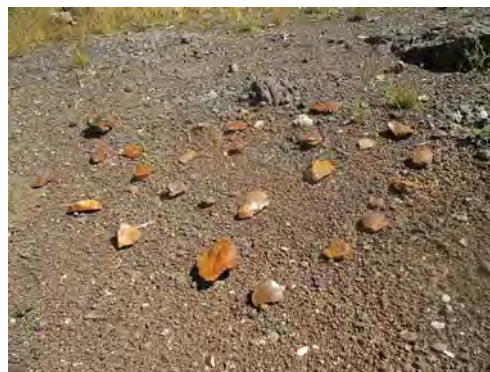
This is a Middle Stone Age site adjacent to the main power generation Sub-station. It is on coordinates : 17 56' 07"S and 25 51' 51.0" E. This site is currently disturbed by ground clearance during maintenance of the the power station.

Figure 4 : MSA Artefacts : Source RM 2015

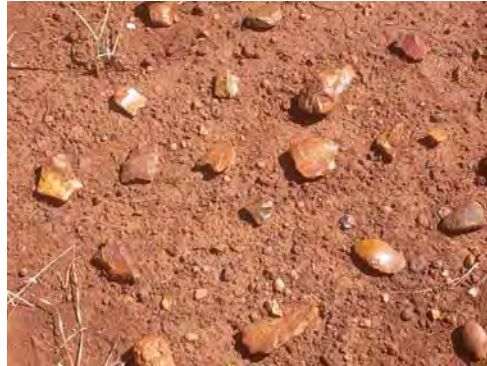
Located on the northern section of the launch pad for the Gorge Swing activity, this is a Late Stone Age site. It is located on coordinates ; 17 56' 42.3" S and 25 51' 26.4" E. This site is completely disturbed by vegetation clearing at the launch pad area.

Figure 5 : MSA Artifacts from Gorge 1 : Source RM 2015

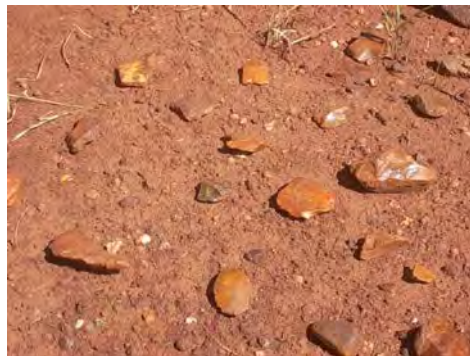
Located on the southern end of the activity platform, the site has the following coordinates ; 17 56' 43.5" S and 25 51' 36.8" E. This is a Late Stone Age site with an extent of about 100 square meters. The site is still intact.

Figure 6: MSA Artifacts from Gorge Swing sites

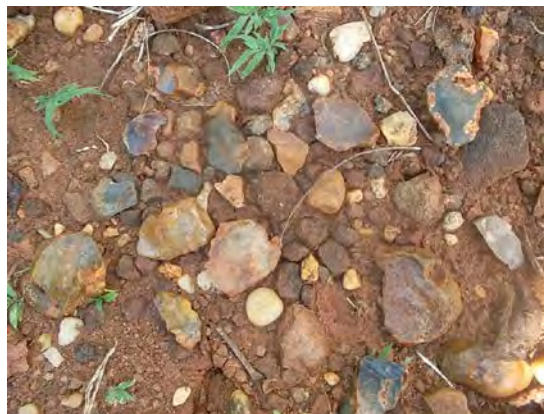
The site is located on coordinates 17 56' 36.2" S and 25 51' 23.0" E. This is another MSA site still intact. It is significant for further research as sits at the confluence of the Songwe River and the Zambezi River. The Zambezi-Songwe river confluence is a very important research area as earlier research has shown a continuous sequence of habitation by all stages of development. Archaeological research by John Desmond Clark at Songwe MSA National Monument site which is just above the confluence, for example, revealed the presence of both ESA and MSA artefacts. In this regard, the Zambezi-Songwe river confluence provides an alternative research site after the earlier excavated site was destroyed by rafting companies that were using the area as orientation and disembarking platform for their clients.

Figure 7 : MSA artifacts from Songwe Gorge Area

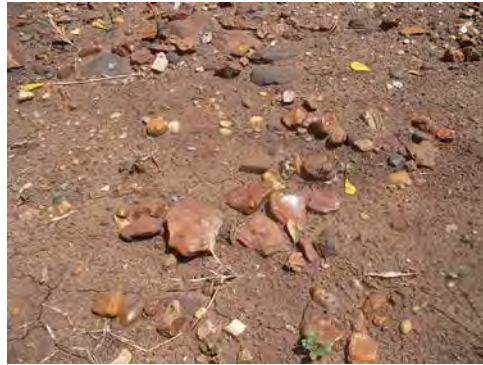
This site is a declared National Monument. Its coordinates are 17 58' 03.8" S and 25 51' 56.4" E. The size of this site exceeds 100 square meters. The site is partially disturbed by many Rafting companies that launch their activities at this site.

Figure 8: showing artifacts from Songwe MSA National Monument site

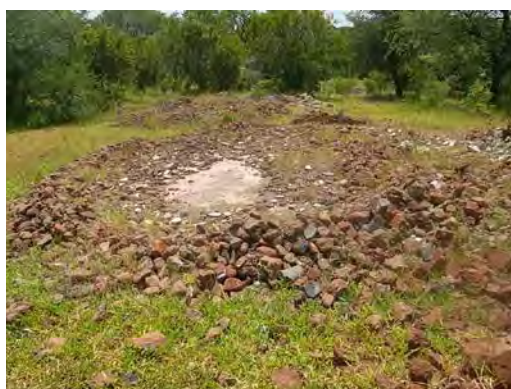
Located at the lip of the Songwe Point Gorge, this site bears both the LSA and IA attributes. Pottery and microlithic stone tools are present. Its coordinates are 17 58' 24.7" S and 25 52' 11.4" E. This site was destroyed by the construction of the now gutted Somgwe Point Lodge.

Figure 9 : Settlement site at Songwe point Lodge

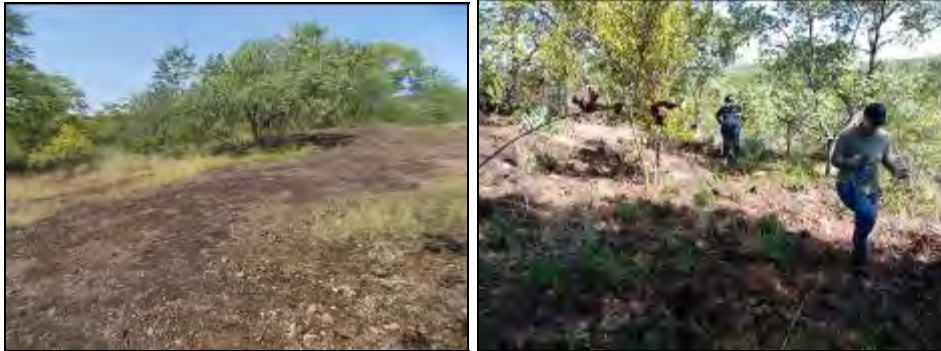
The survey was conducted using “West-to-East” transects within the proposed quarry footprint. Different environmental areas were surveyed for possible heritage resources. These included both open and forested areas (Figure 3).

Figure 3: Some of the areas surveyed for heritage resources

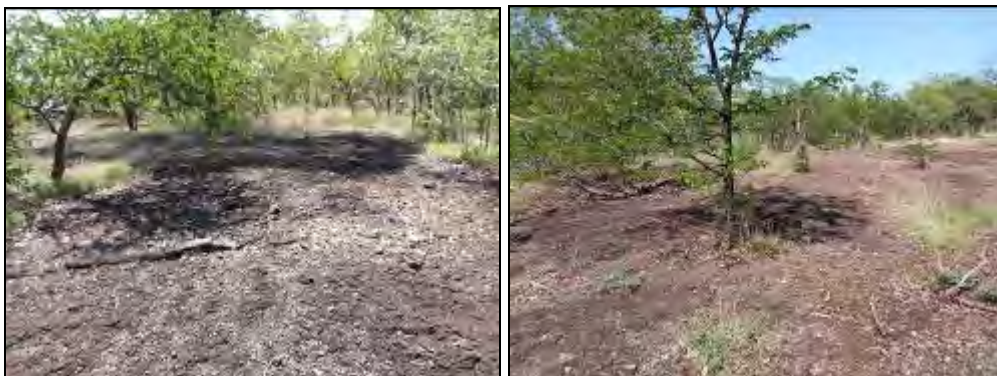
No archaeological or other cultural heritage resources were identified in the proposed quarry area. Furthermore, no fossils, graves, sacred or traditional sites were discovered in the study area. This is largely attributed to the fact that the proposed quarry site has never been inhabited by the Leya or any other ethnic group in the past or at present as the area in question is generally hilly, rocky and rugged (Figure 4) and not suited to human settlement.

Figure 4: Rocky and rugged landscape characteristic of the project area
