# **HERITAGE IMPACT ASSESSMENT: PROPOSED LOXTON WIND ENERGY FACILITY 2, CARNARVON AND VICTORIA WEST MAGISTERIAL DISTRICTS, NORTHERN CAPE**

Required under Section 38(8) of the National Heritage Resources Act (No. 25 of 1999)

SAHRA Case ID: 20118

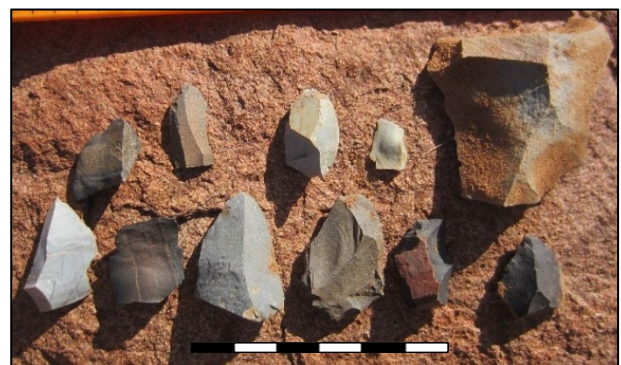
**Figure 16:** Stone artefacts on hornfels and chert from waypoint 1988. Scale in cm.

Stone Age materials were rarely found. No ESA artefacts were seen and MSA artefacts were restricted to rare background scatter items. One LSA site was found at waypoint 1988. The site lies on an open sandy patch atop a dolerite dyke and is some distance from the nearest river (Figure 15). The artefacts were on hornfels and chert (Figure 16). Many pieces of ostrich eggshell were also seen.

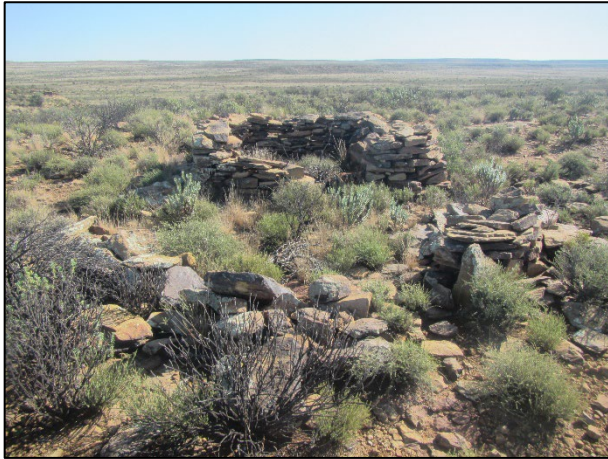
**Figure 18:** Stone-walled hut in the background with a vestibule in the foreground at waypoint 1272.

Slightly more formal was a stone walled structure that must have been a shepherd's hut at waypoint 1272 (Figure 18). The main room of the structure was about 2 m by 2 m but a 3 m diameter and opens into a slightly less formally built vestibule that lies to the south. A few historical items were noted in the area (Figure 19).

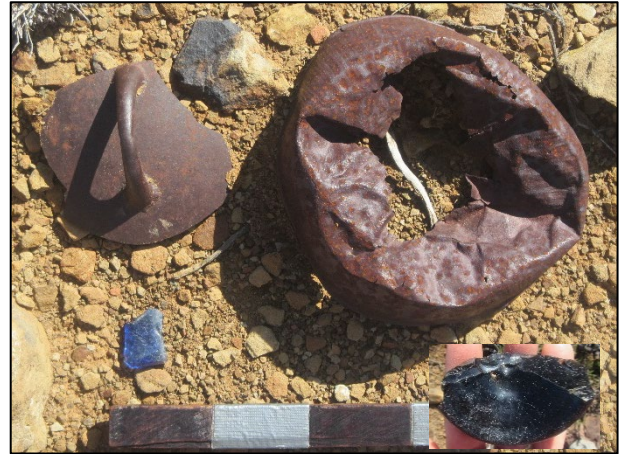
**Figure 19:** A fragment of potjie, an enamel bowl, and pieces of cobalt blue and black bottle glass from waypoint 1272.

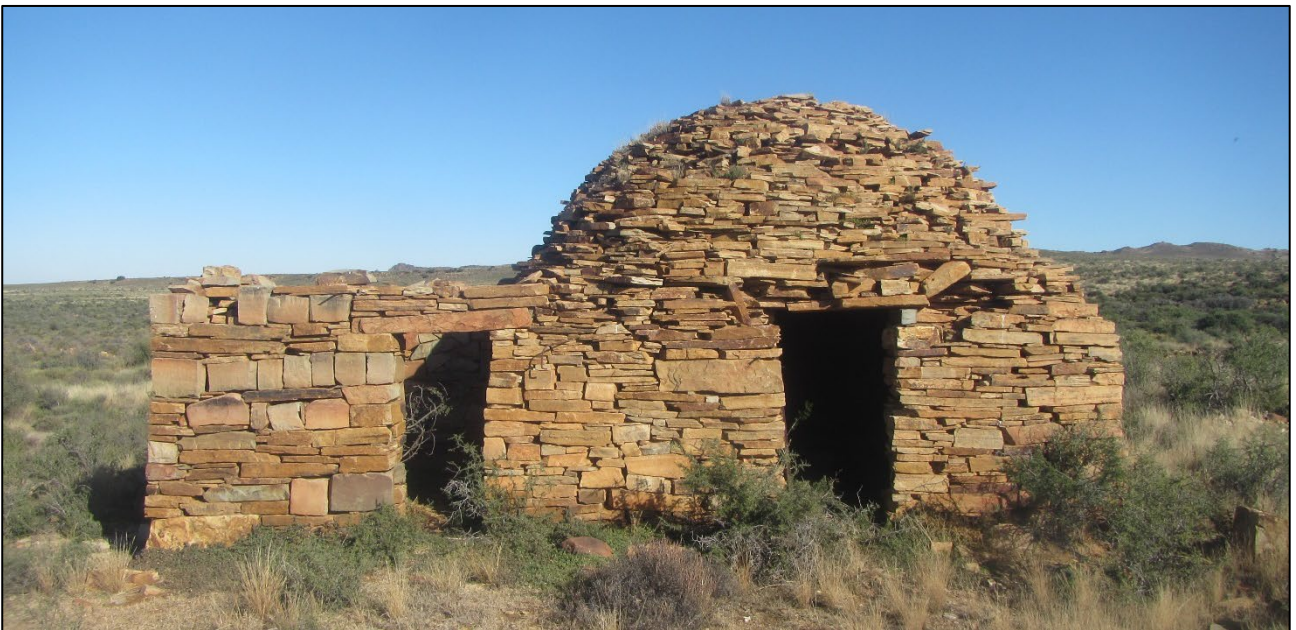
**Figure 21:** East and north sides of the corbelled building at waypoint 1270.

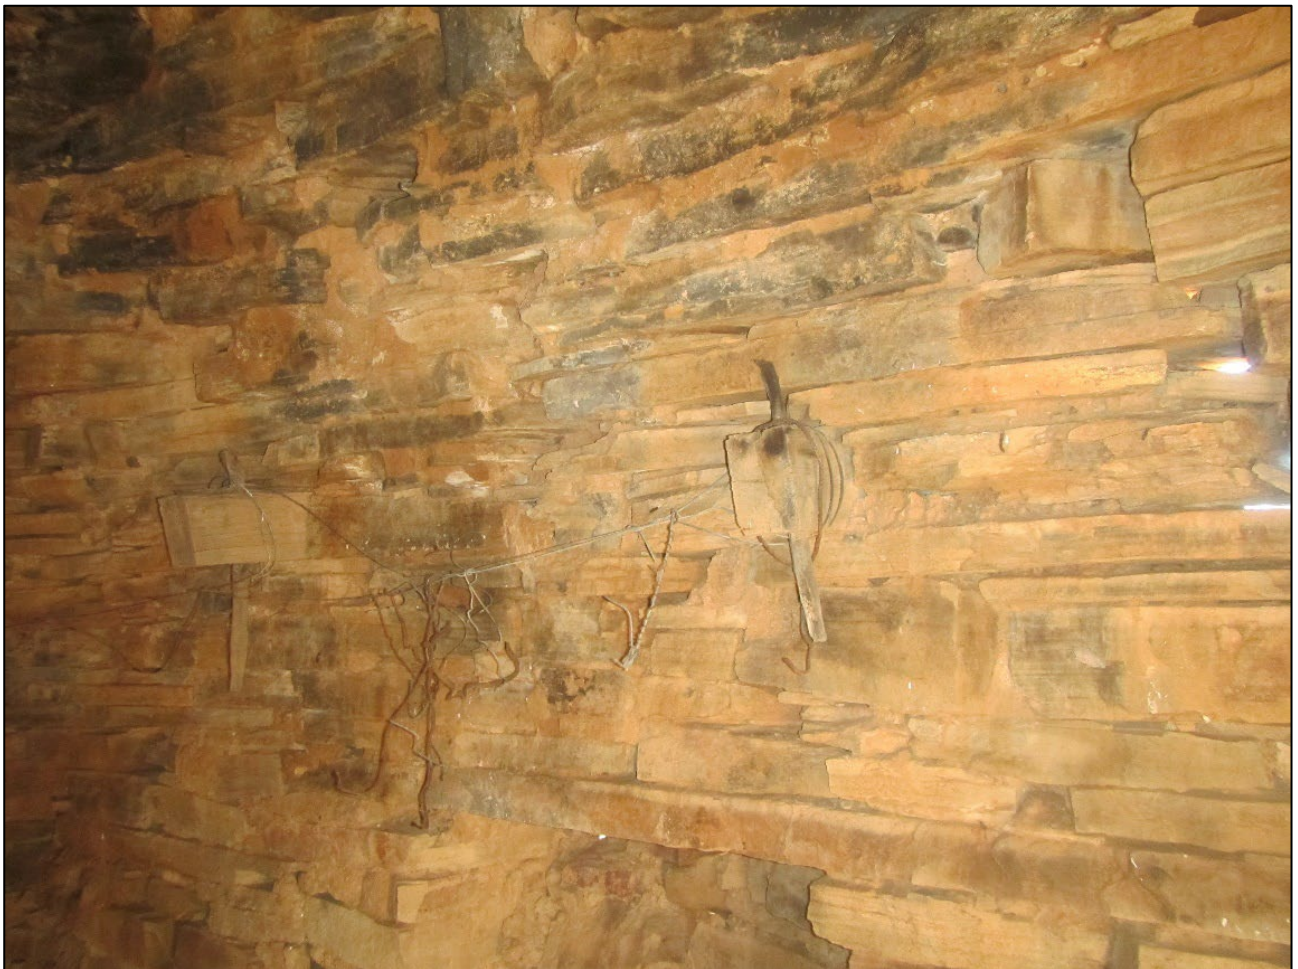
**Figure 24:** Internal features of the corbelled building at waypoint 1270. Two pierced wooden blocks with pegs through them are visible in the wall above the lintel of the now closed up northern door. Some wire has been fastened to the wooden blocks.

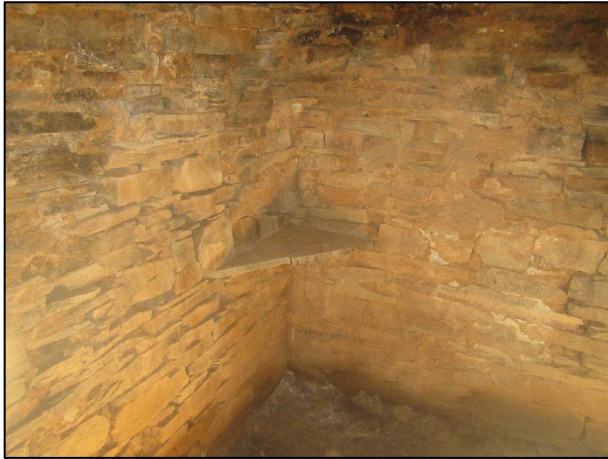
**Figure 25:** Internal corner shelf in the corbelled building at waypoint 1270.

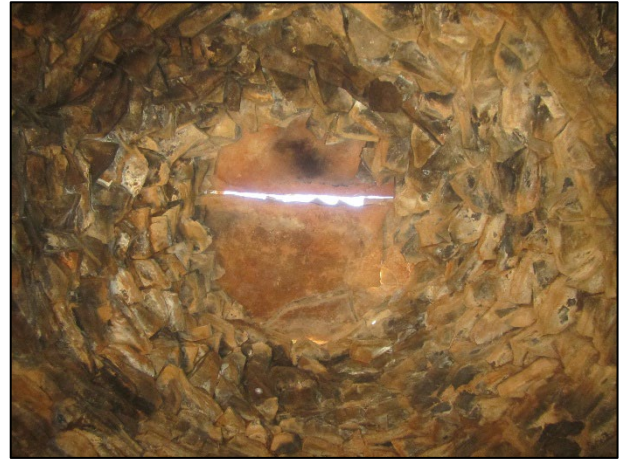
**Figure 26:** The inside of the dome in the corbelled building at waypoint 1270 showing two large slabs closing the top.

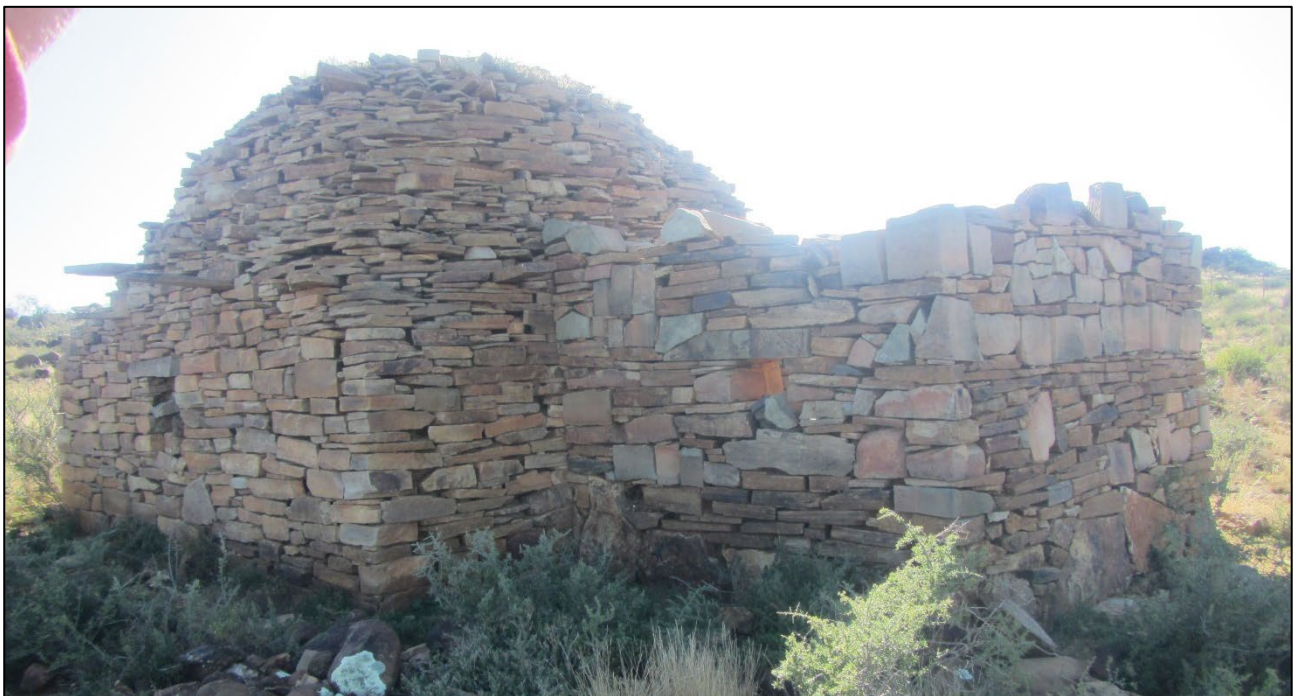
**Figure 27:** West and south (with added flat-roofed room) faces of the corbelled building at waypoint 1270.

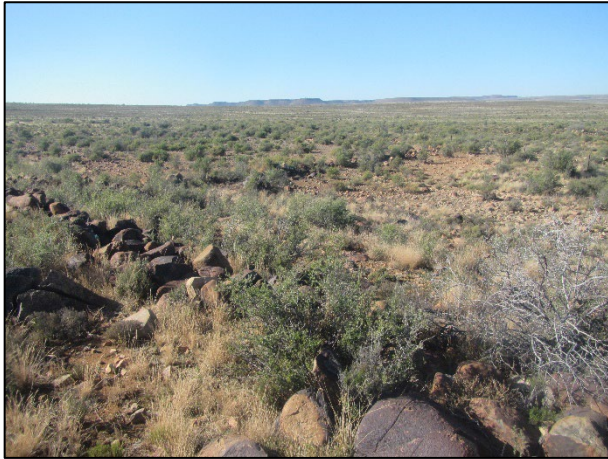
**Figure 28:** Stone-walled kraal at waypoints 1268-9.

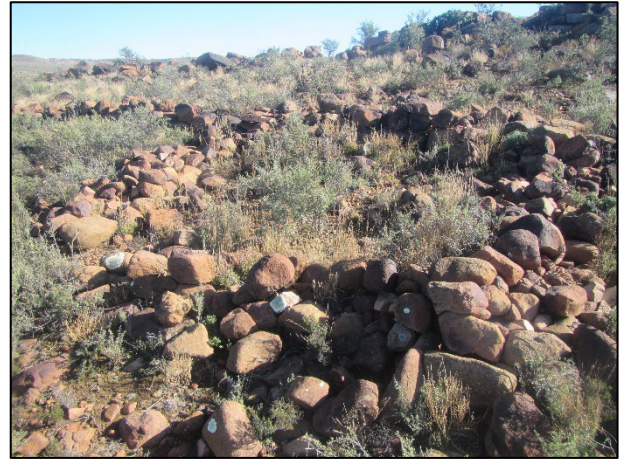
**Figure 29:** Stone-walled feature at waypoint 1269.

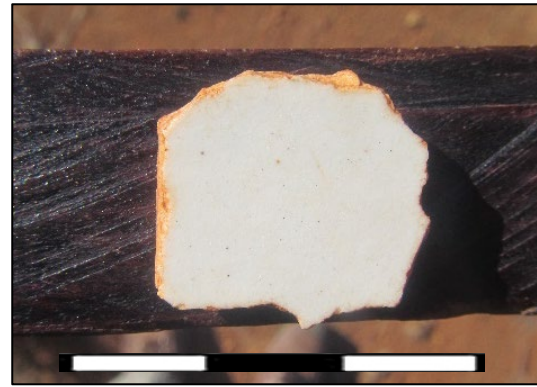
**Figure 31:** A likely game counter made on a willow pattern sherd at waypoint 1233. Scale in cm.

**Figure 32:** A likely game counter made on a willow pattern sherd at waypoint 1233. Scale in cm.

Although only an isolated artefact, one other historical observation of interest was a ceramic game counter seen at waypoint 1233 in the absence of any other associated materials. It was clearly dropped there on purpose or by mistake. It was made on a piece of willow pattern refined white earthenware (Figures 31 & 32).

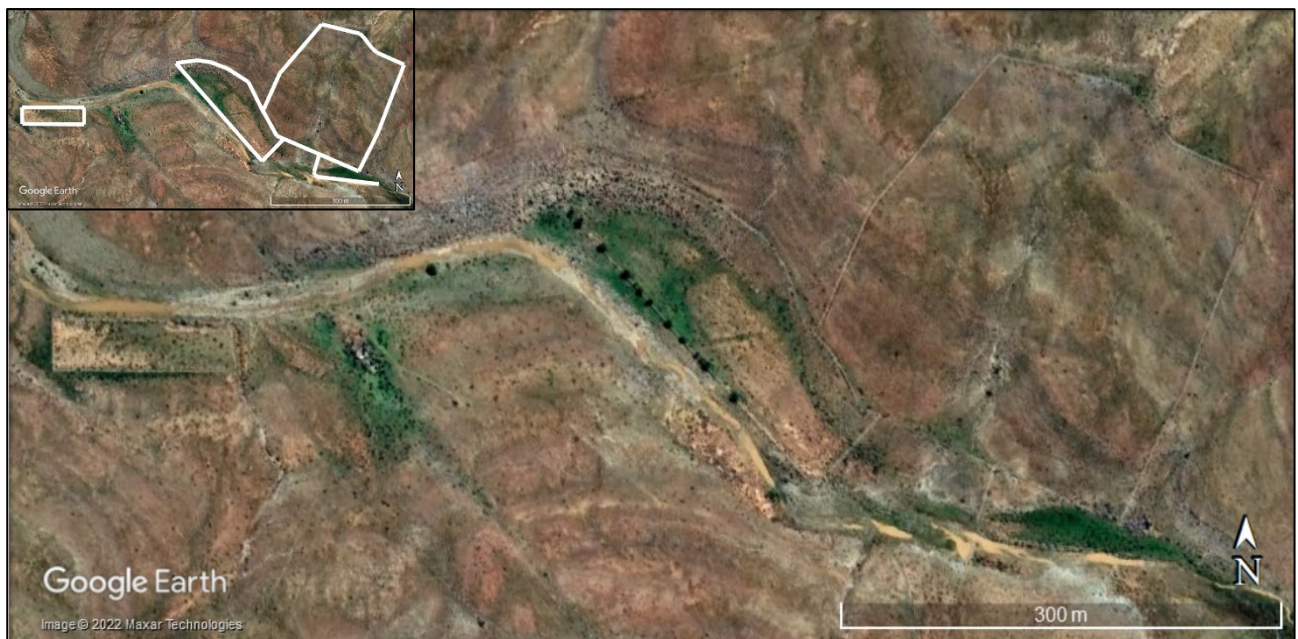
**Figure 33:** Aerial view of the stone-walled features at waypoints 013 (left) and 014 (right). The inset shows the exact same view but with the walling highlighted.

Further archaeological features were seen on aerial photography. Most impressive was a series of large walled features to the west of the Aarfontein farm complex. While two are clearly garden areas because they lie on the river floodplain, one of far larger and extends up the hill to the north of the river (Figure 33).

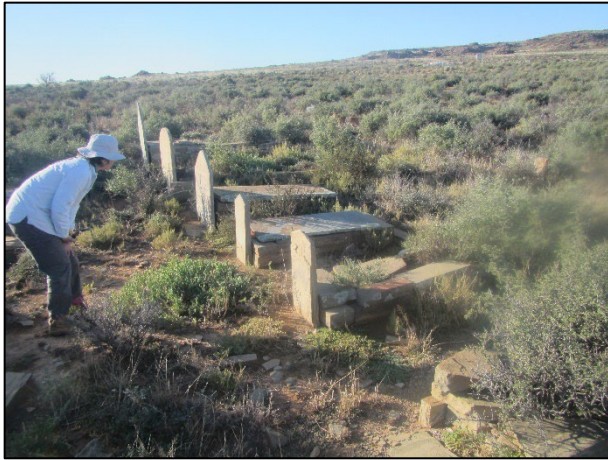
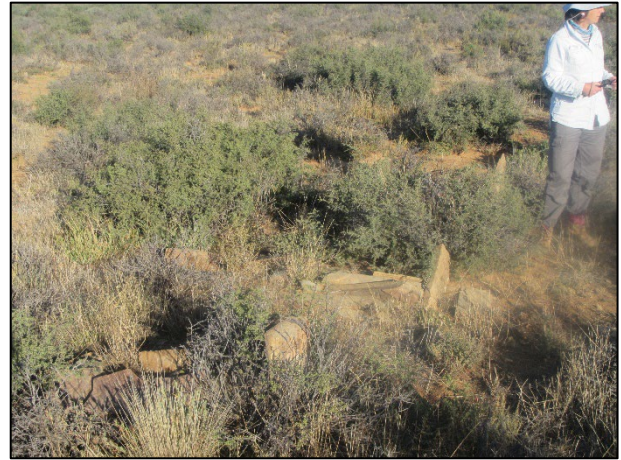
**Figure 34:** Graveyard at waypoint 1281 in the Ystervarkspoort farm complex.

**Figure 35:** Graveyard at waypoint 1281 in the Ystervarkspoort farm complex.

No isolated graves were seen during the survey but a graveyard was found in the Ystervarkspoort farm complex.

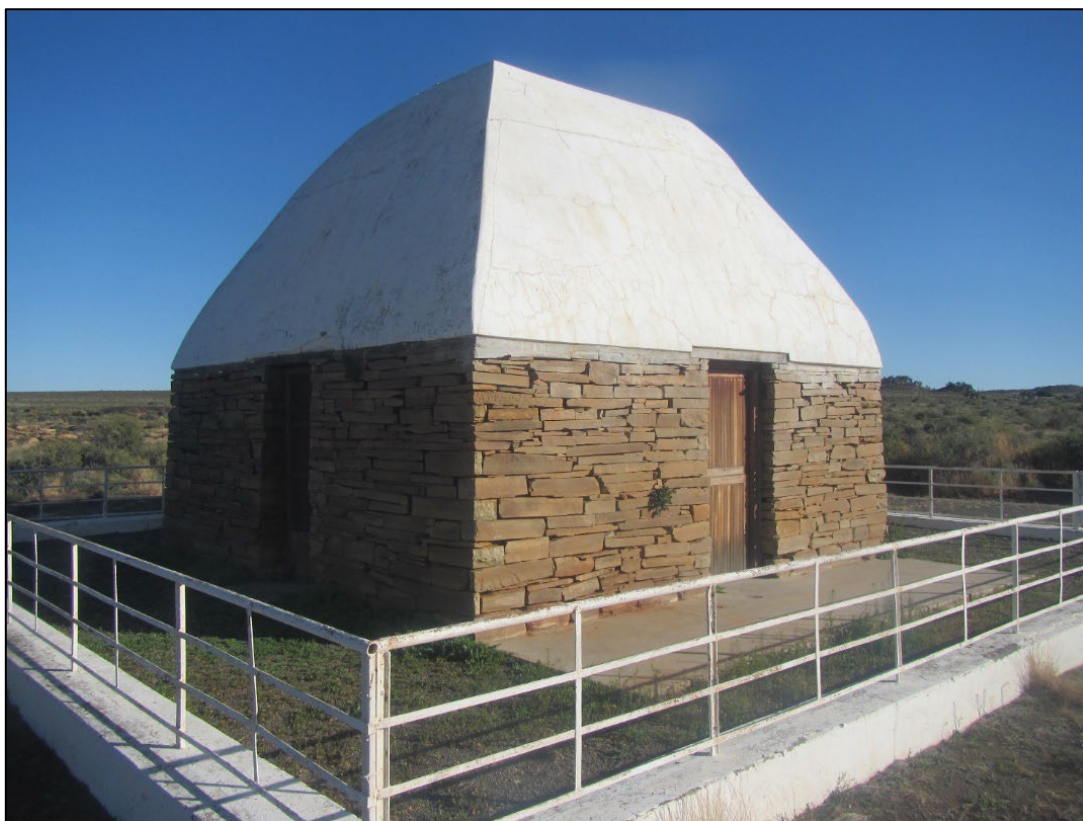
**Figure 38:** The corbelled building at waypoint 1265 and recorded as Ystervarkspoort 1 by Kramer (2012).

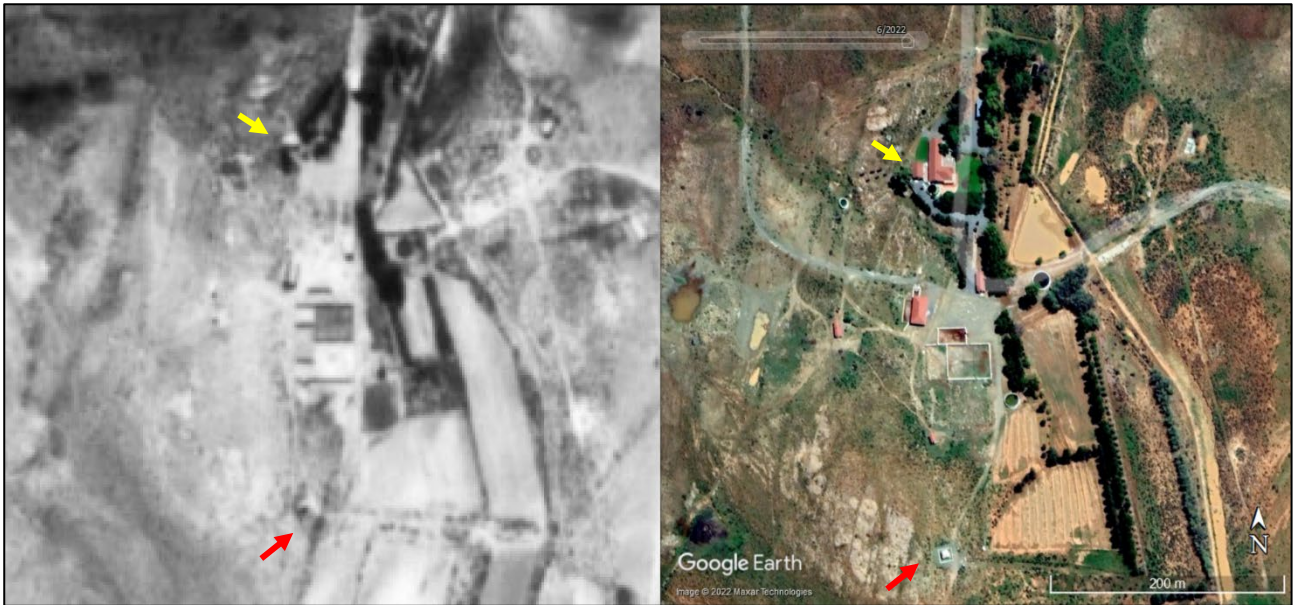
**Figure 40:** Historical aerial views from 1960 (434\_005\_02986) and today (Google Earth) of the Ystervarkspoort farmstead. Arrows show the corbeled building (red) and small outbuilding (yellow) behind the current farmhouse which does not seem to have been present in 1960.

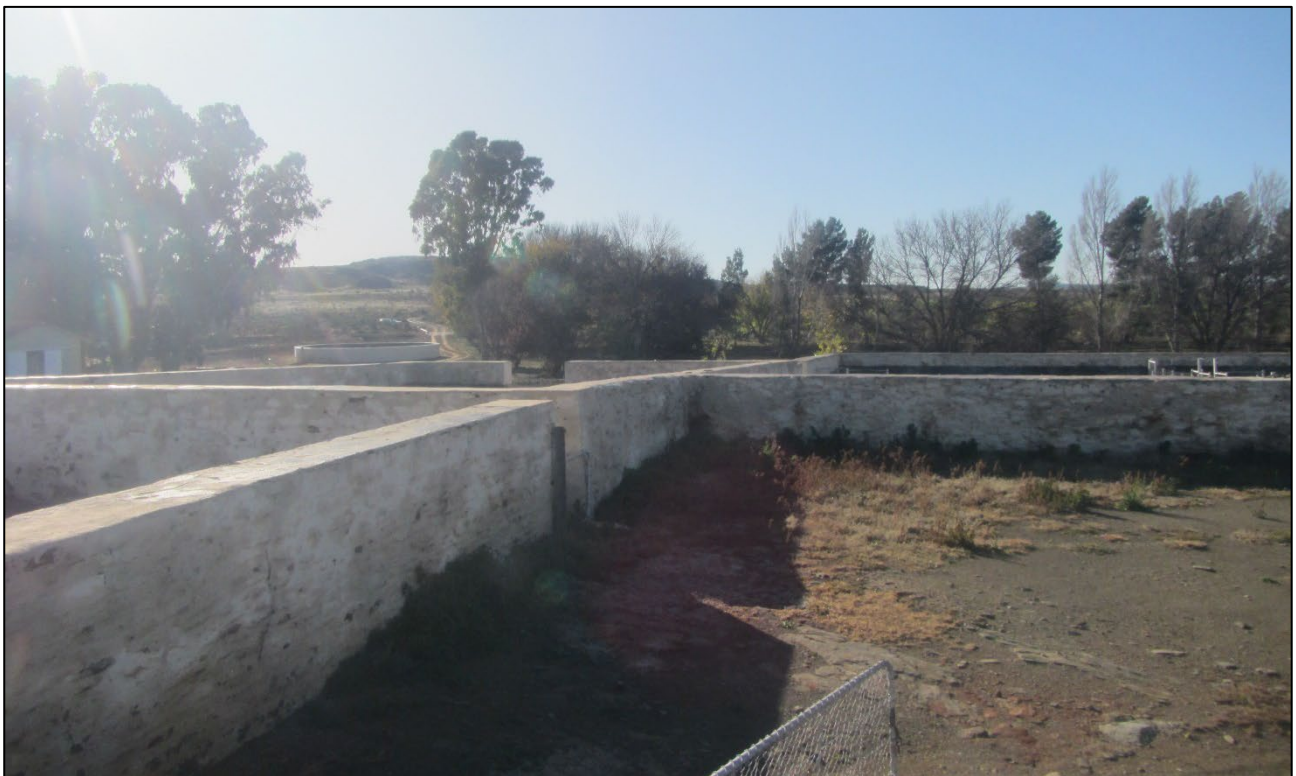
**Figure 41:** The well-preserved remaining section of the stone-walled kraal complex at waypoint 1264.

Historical and built heritage resources all occur along river valleys and they are generally few and far between. Only one farmstead was visited during the survey and this was that at Ystervarkspoort in the east. There are two generations of farmhouses with the oldest being a corbelled building that has been renovated and maintained. Although it has lost its charm by having its corbelled dome plastered and painted, the overall structure will certainly last longer (Figure 38). The current farmhouse appears to date to the mid-20<sup>th</sup> century (Figure 39), and seemingly after 1960 (Figure 40). Another structure on the farm may have served as a house in between. Other features include a stone-walled kraal complex which, according to the evidence of Figure 40, has been partly dismantled sometime during the last 60 years. The remaining section, however, is well-preserved and well-maintained (Figure 41).

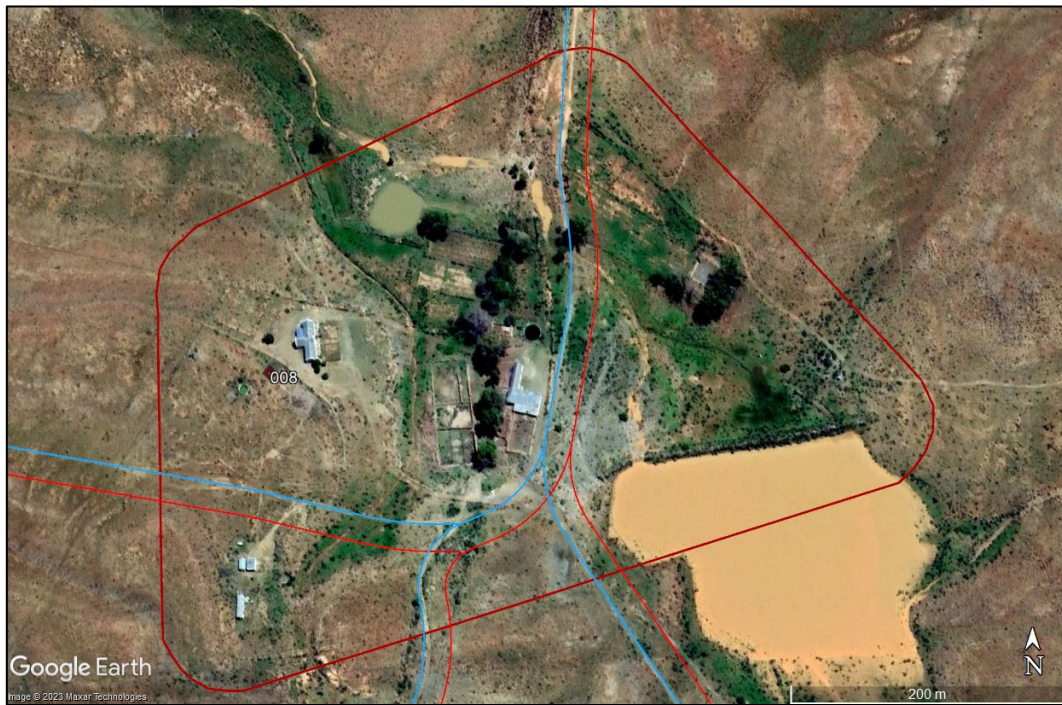
**Figure 44:** Aerial view showing project roads (blue) and cables (red) passing through the site at waypoint 003.

Table 8 provides project responses to the heritage indicators with mapping shown in Figures 44 to 46 where needed. The main concern relates to the site at waypoint 1238 which would require avoidance or mitigation as noted in Table 8. In other places where existing roads are being reused the heritage resources can be protected through clear No-Go signage and monitoring.

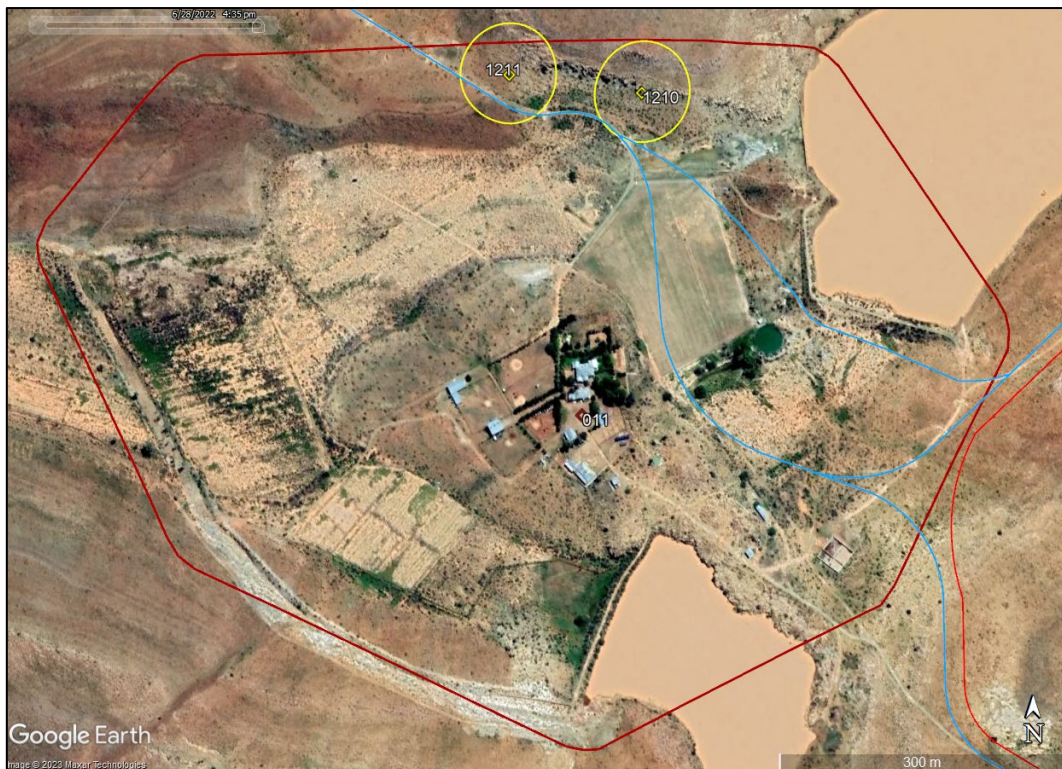
**Figure 45:** Aerial view showing project roads (blue) and a cable (red) passing through the site at waypoint 011.

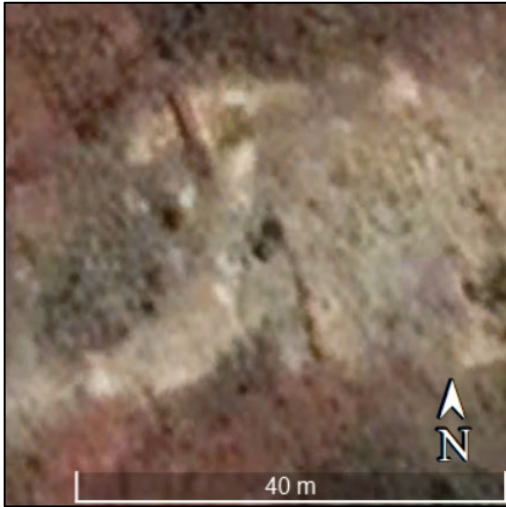
WEF project area	WEF access road	Waypoint	Location	Description	Significance	Grade
1		1218	S31 16 13.3 E22 22 03.7	A large dam wall with stone-packed sections. The centre of the wall is breached. The wall is approximately 100 m long.	Low	GPB
1		1219	S31 16 09.6 E22 22 20.6	Some recent lettering scratched on a dolerite boulder. "FJDT...". Unlikely to be 100 years thus not heritage.	---	---
1		1220	S31 15 53.3 E22 22 35.8	<p>A pair of small stone walls forming low weirs in a stream bed. It is unclear if they were once linked to form a single structure as they are offset from one another. The stream flow is from right to left in the aerial view below.</p>
