Annex D

Consequence Modelling Results

D1 CONSEQUENCE ISO-PLETH CALCULATION

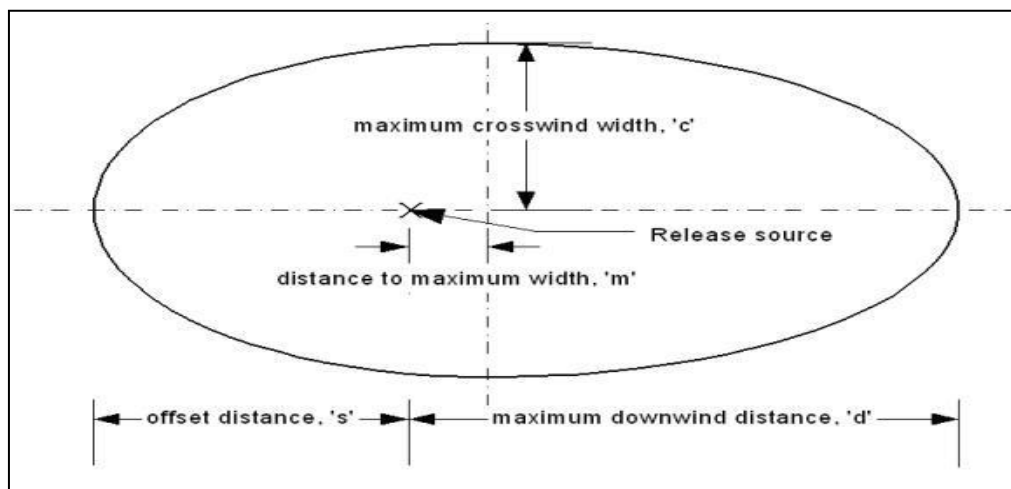
Figure D.1 Consequence Zone Representation

Figure D.1 illustrates the various consequence zones. Each consequence is described according to the elliptical shape described in Figure D.1.
